PROGRESS REPORT

# Riverside House Refurbishment

Ref: RHR-2026-014

| Reporting Period | 1 July 2026 — 28 July 2026 |

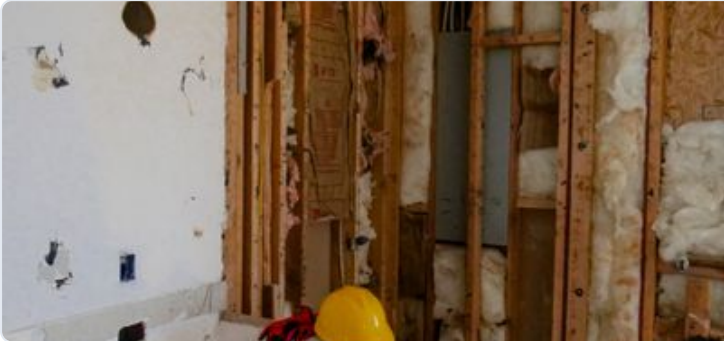
Ready for structural opening-up

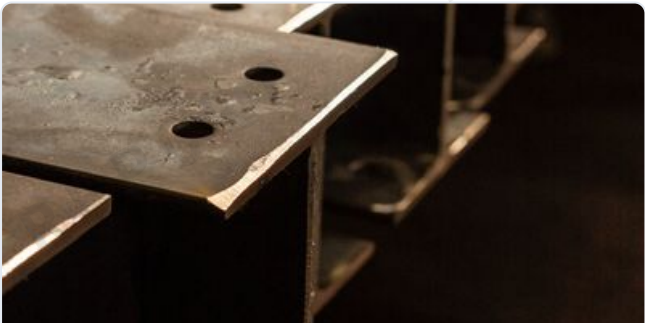
Beams checked against GA drawing — 2 no. UB406 short, chased with fabricator

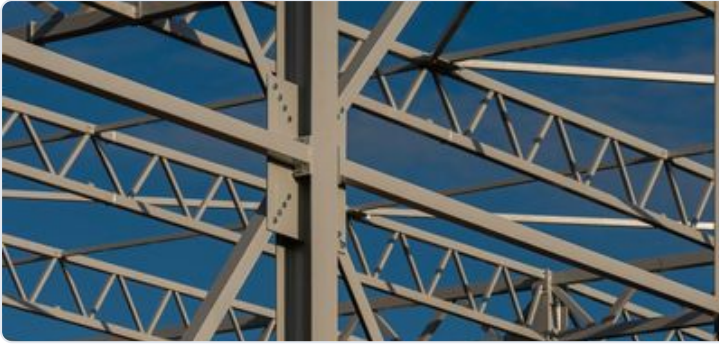
### Frame plumbed and bolted, awaiting inspection

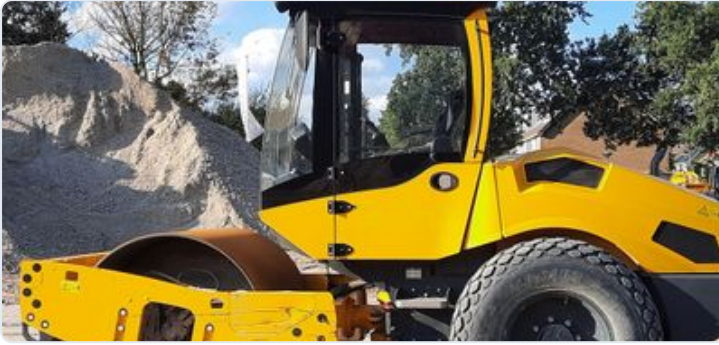
External Works & Landscaping has been flagged as delayed ahead of its planned 7 Sept – 16 Oct 2026 window — site note: “Held up by plant availability — flagged as delay risk”.

**Held up by plant availability — flagged as delay risk**
